TEST REPORT

Report No.: HC90024/2015 Page: 1 of 4 September 17, 2015 Date:

The following merchandise was submitted and identified by the vendor as: Product Description: Industrial Multi-Touch Panel PC Style/ Item No.: MTC-2021 / No.1 Total 1 piece Quantity: Sep. 2, 2015 to Sep. 16, 2015 Testing Period:

1. Random Vibration Test

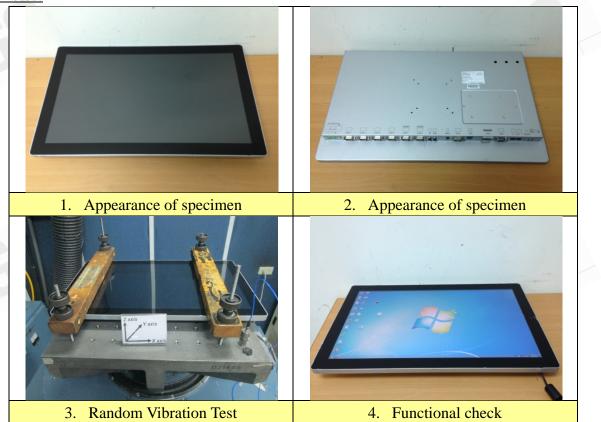
Test Photos:

Sample condition:	Non-Operating			
Wave form:	Random			
Frequency:	<u>(5~500) Hz</u>			
	Frequency (Hz)	Left Slope (dB/Oct.)	PSD (G ² /Hz)	Right Slope (dB/Oct.)
	5		0.0045	0
	500	0	0.0045	—
	⇒ equivalent	t to 1.5 G _{rms}		
Direction:	X, Y, Z axes (se	e photo 3)		
Duration:	30 minutes/ axis	<u>s</u>
